Grand Canal, Dublin

Contractor—Fressinet/ Norfolk Marine

Owner—Waterways Ireland

The stonework gravity walls to the historic dock basin were suffering from face failure underwater due to loss of its original weak lime mortar. An underwater concrete face repair was selected as the repair method, nominally 100 mm thick. A 10 m long mesh control frame system was adopted which carried a fabric formwork face shutter connected to base and leading side grout bag seals.

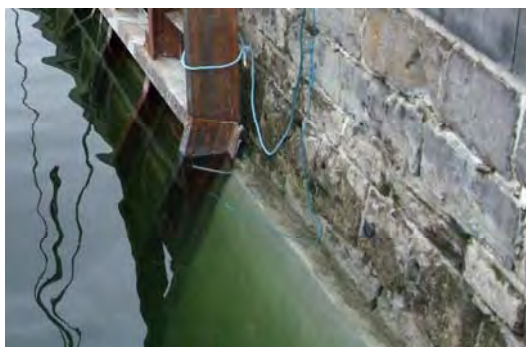
Top of Concrete Wall Repair

The frame was temporarily supported by driven piles with rams to the bottom and drilled anchor ties to the top. The shutter system was filled with a sand: cement micro concrete. The bleed combination of the micro concrete mix and fabric face formwork quickly reduces concrete filling pressures and allows a lower weight frame system to be used. It also produced a good quality concrete face repair which also infilled failed stonework areas.
