Holt Weir, River Severn, U.K.

Contractor—A.W.G.

Owner—British Waterways

Fabriform

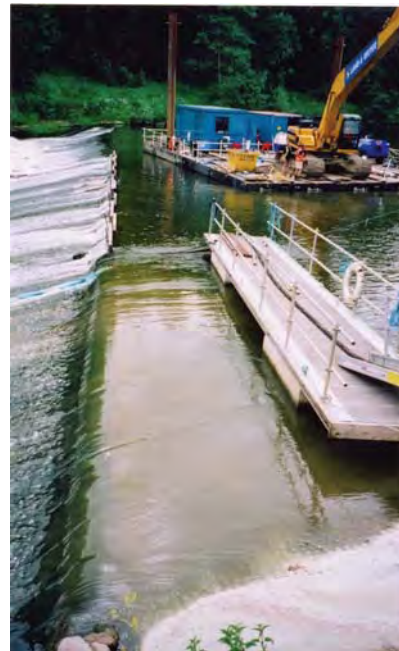
**Mattress Construction
Progressing Across Weir**

The upstream slope and toe was excavated and profiled by barge mounted excavator. The mattress was laid and filled by divers working in areas boarded off from the river flow.
